SAINT MARYS, PA
NEAR RIDGWAY 15 QUADRANGLE
N4122.5—W7830.7.5
1969

LANDSLIDES AND RELATED FEATURES OF THE ST. MARYS, PA. QUADRANGLE

by
John S. Pomeroy
1981

U.S. Geological Survey
OPEN FILE MAP 81-238 (D-12)

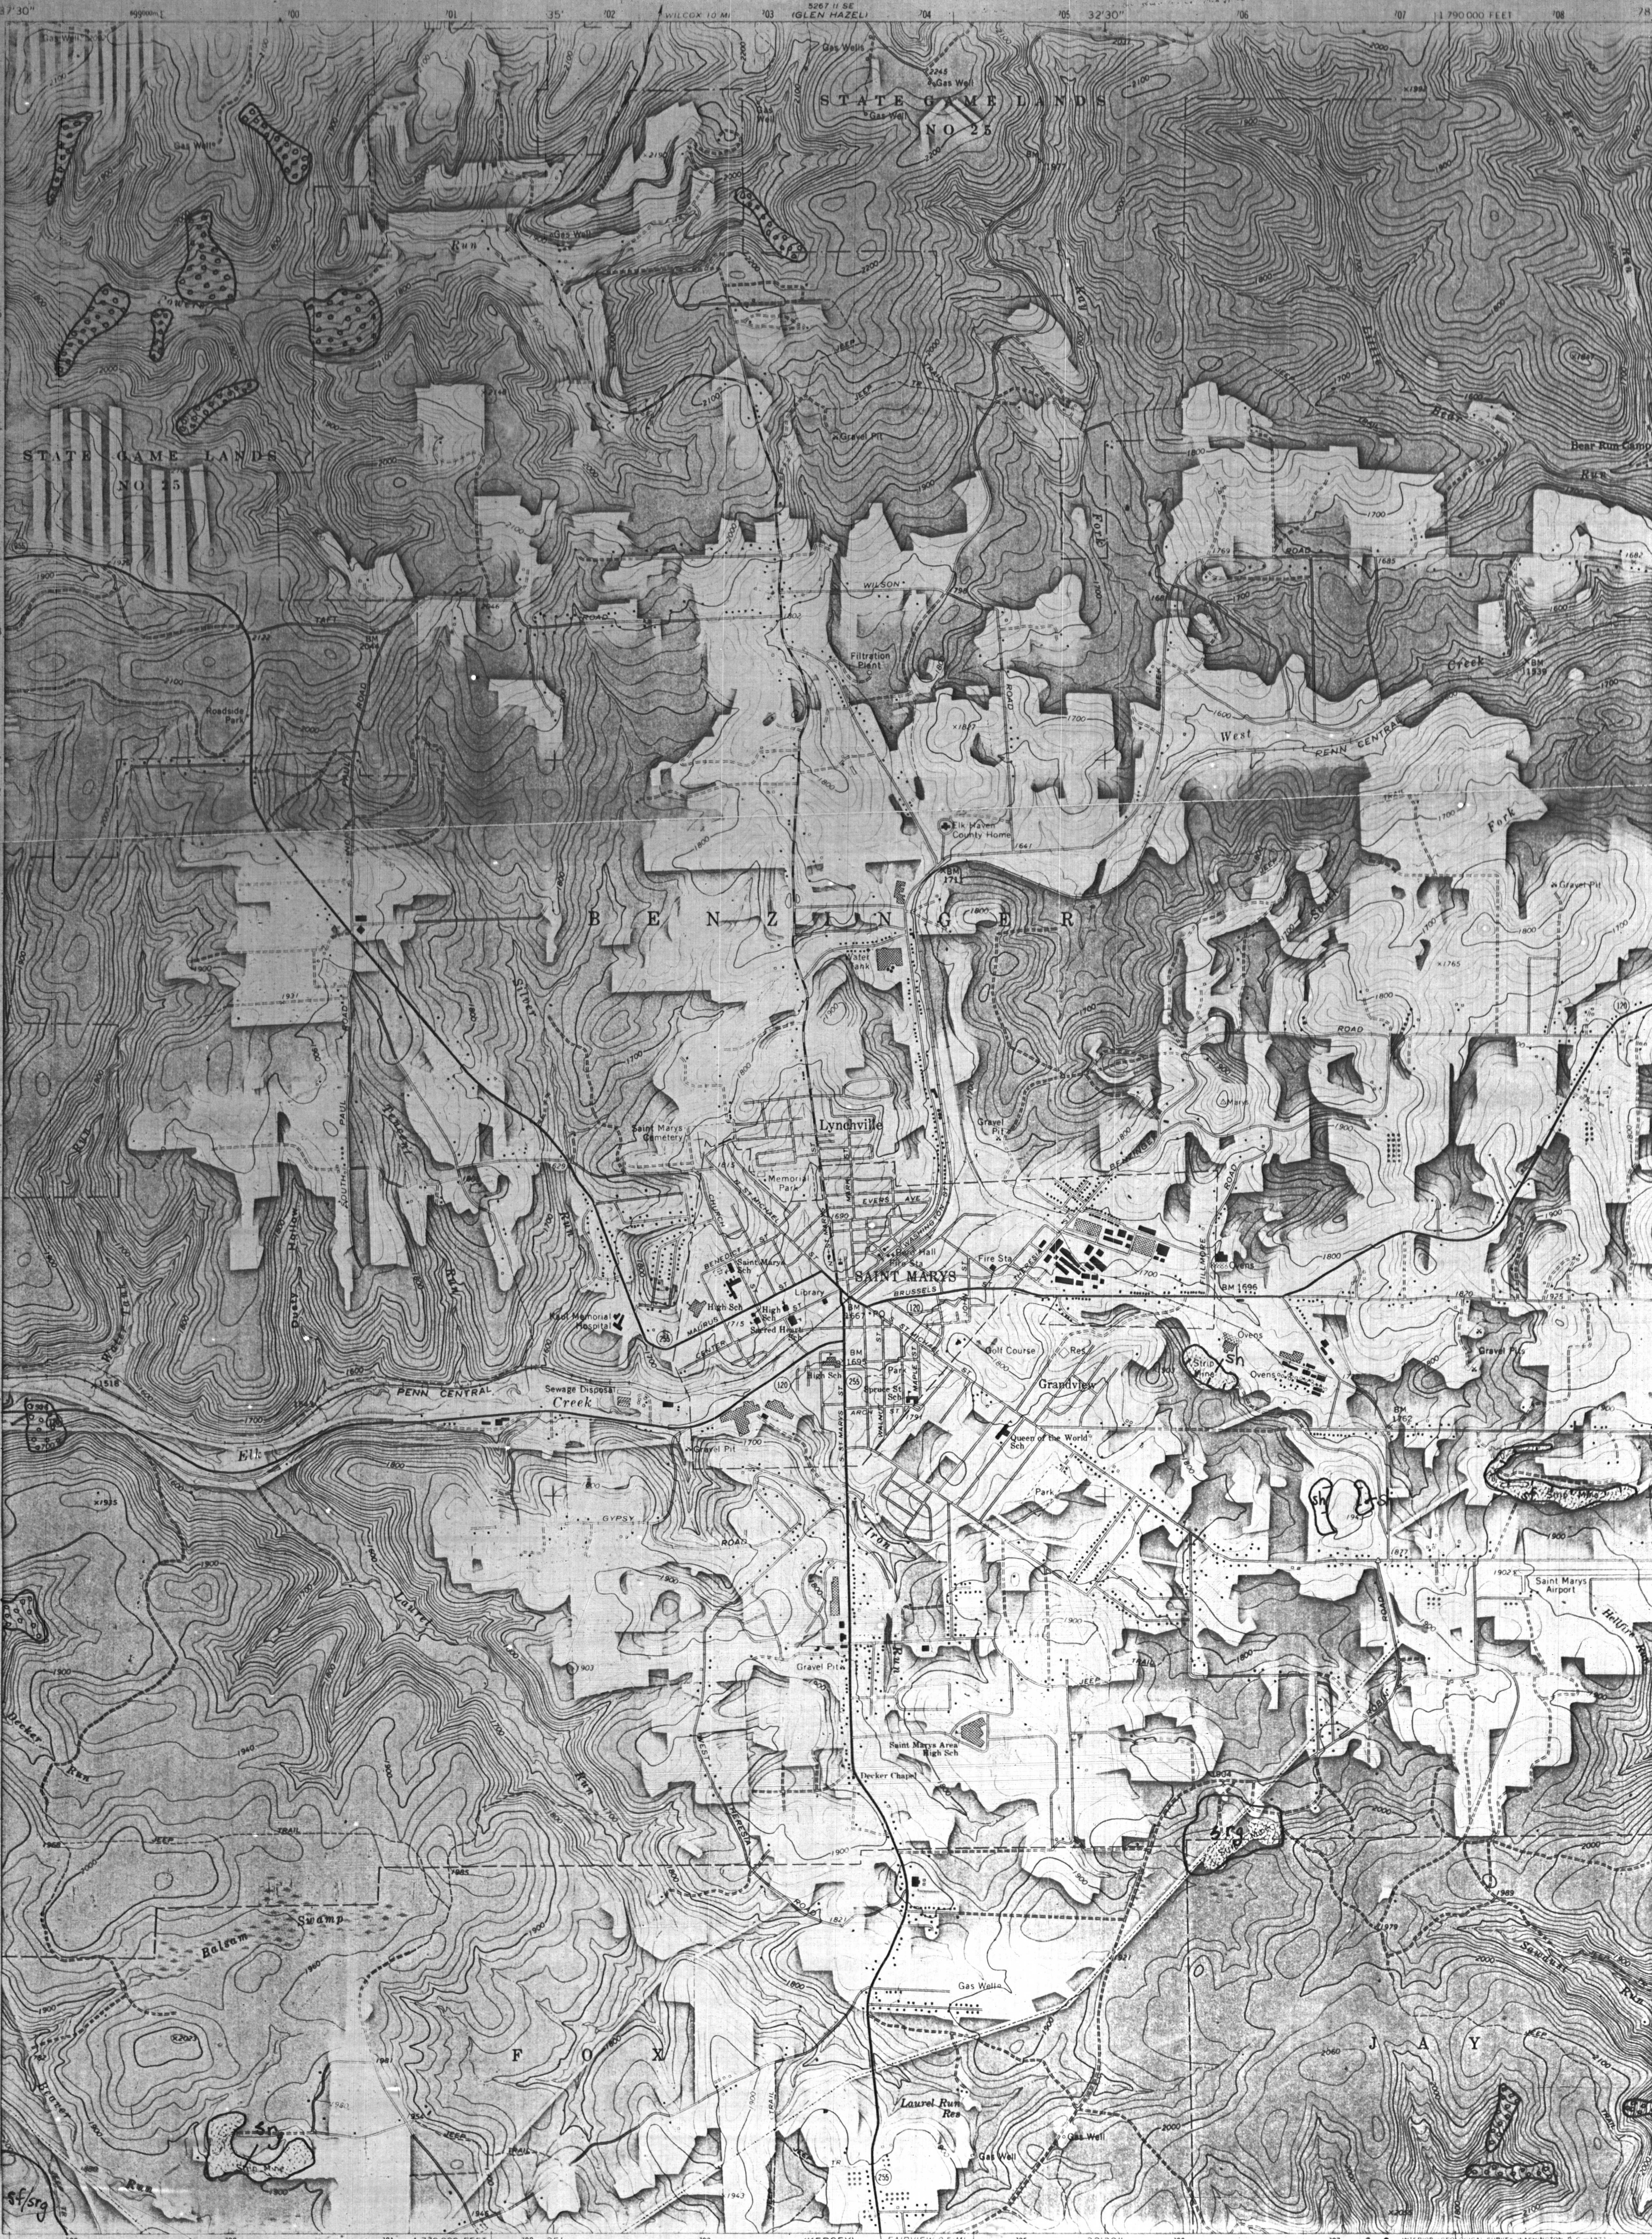
MAN-MADE FEATURES
Strip mines (combination of letter symbols indicates complex formed of more than one type of strip mine)
sh bench with high wall
sf furrowed with high wall
sd multiple furrows and multiple benches
ss hilltop removed
srg reclaimed by grading
sru reclaimed by secondary use
sh/r regraded in part, high wall remains
Coal refuse banks
r identified on aerial photographs; not classified in field check
rb not burnt nor on fire
rbb burnt
rbd burning
rbs sludge
Quarries
q quarry site
qub spoil bank, quarry waste
Gravel pits
g site of gravel pit
Slides in man-made features
af earth flow in fill
a/s earth flow in strip castings
a/r earth flow in coal refuse

AREAS SUSCEPTIBLE TO DEBRIS FLOWS AND DEBRIS AVALANCHES
Primarily shallow, narrow ravines and chutes with accumulation of stony colluvium generally 10 ft. (3 m) or less in thickness; susceptible to rapid movement during intense rainfall. Most ravines and chutes designated show evidence of former debris flows and avalanches. Symbol & designates historical debris flow or debris avalanche.

AREAS SUSCEPTIBLE TO ROCKFALL
Steep, locally vertical, natural and man-made slopes and cliffs, 15 ft. (4.5 m) or more high; formed dominantly of sandstone, limestone, sandy shale, mudstone and claystone. Interbedded mudstone, claystone and shale weather rapidly leaving sandstone and limestone rock faces unsupported.

SOIL AND ROCK SUSCEPTIBLE TO LANDSLIDING
Soil and rock similar to that involved in landslides elsewhere in map area; primarily areas underlain by claystone, mudstone and shale associated with other rock types. Rock weathers rapidly on exposure forming clayey soil highly susceptible to sliding. Includes coves (U-shaped, shallow valleys) containing thick layers of clayey soil that are very susceptible to sliding where excavation breaks continuity of slope and where overloaded by artificial fill.

AREAS LEAST PRONE TO LANDSLIDES
Map areas in which no patterns or symbols are shown; primarily valley floors, ridge tops and broad benches; modification by excavation and fill may lead to local landslides.
Includes slopes where landslides are sparser.

ACTIVE OR RECENTLY ACTIVE LANDSLIDE
Complex landslide composed of earthflow, debris slide, earth and rock slump. Identified from historical records, and from scars, debris and other field evidence. Ground extremely unstable; sliding accelerated by excavation, loading and changes in drainage conditions. May include areas with several active slides too small to be shown separately. Questioned where doubtful. May be shown with symbol (A) where difficult to discern.

OLD LANDSLIDE
Area of extensive hummocky ground caused by earthflow and earth and rock slump. Lacks clear evidence of active sliding. Relatively stable in natural, undisturbed state, generally not affected by small structures properly sited in areas away from the edge of the toe; can be reactivated by extensive, rapid excavation, loading, and changes in ground water and surface water conditions. Area of old landslide probably includes recent ones not identified from field evidence or otherwise documented. Upslope boundary of landslide generally defined by modified scarp, but downslope (toe) may be gradational and not well defined. Questioned where doubtful.

COLLUVIAL SLOPE
Valley wall along major streams with slope as steep as 40° (85%); stony, clayey silt soil up to 50 ft. (15 m) thick; commonly buttressed by a terrace or bench at the toe of the slope; very susceptible to sliding by cutting of toe area, removal of terrace or bench, and overloading; slide commonly activated without apparent cause.

NOTE
Information shown is intended as a general guide to ground conditions as of the date of field check. Additional landslides and rockfalls should be anticipated in all map units. The map unit depicts the dominant condition in the area delineated and variations in slope stability may occur at any point in the unit. This map is suitable for general planning purposes and as a supplement to more detailed studies for site selection. The map cannot be used as a substitute for detailed geologic and engineering investigations to establish design and construction criteria of specific sites. Some symbols may not appear on this map because the description is applicable to a series of maps.
